緊急現場安全通知**醫療器材矯正****URGENT FIELD SAFETY NOTICE****MEDICAL DEVICE CORRECTION**

“德塔斯” 主動脈氣球導管幫浦(衛部醫器輸字第 025453 號)
Datascope Cardiosave Hybrid and Rescue Intra-Aortic Balloon
Pumps (IABP)

Datascope Corp., a subsidiary of Getinge is initiating a voluntary Medical Device Correction for the Cardiosave Hybrid and Cardiosave Rescue Intra-Aortic Balloon Pump (IABP) due to four issues that could affect IABP performance:

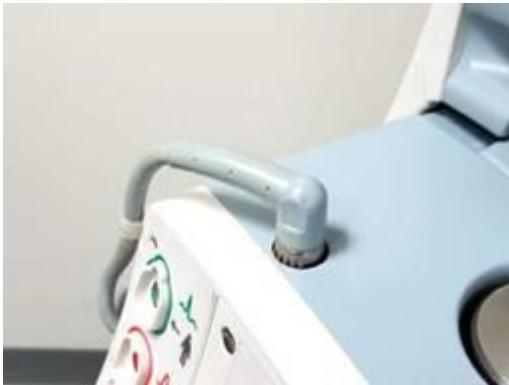
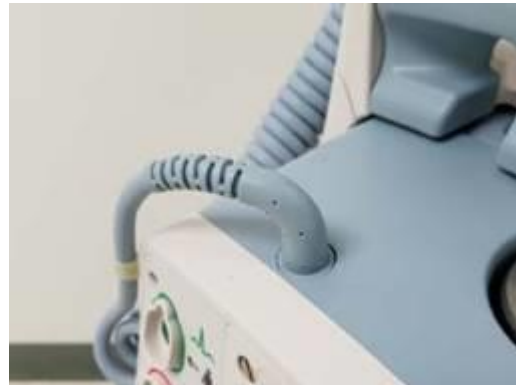
Figure 1: Representative picture of both the old and new Coiled Cable cord design.

議題 1：因捲線電纜和電纜組件背板到捲線電纜的故障而意外關閉**Issue 1: Unexpected shutdown due to failure of the Coiled Cord cable and Cable Assembly backplane to Coiled Cord cable****問題識別：**

An internal investigation of the complaints determined an unexpected shutdown may be due to damaged Coiled Cable Cords [part numbers 0012-00-1801 and 0012-00-1796] that provide bidirectional communication between the display head and base unit. Please refer to images below for reference.

Datascope/Getinge has received 25 reported complaints of damaged Coil cords resulting in unexpected shutdown over a 2 year period.

Prior to use of the Cardiosave IABP, inspect the coiled cable cord to ensure that there is no visible damage.

Datascope/Getinge has developed a hardware correction to address this issue. It is important to note that this issue is limited to units distributed prior to July 24, 2017. A Datascope/Getinge service representative will contact you to schedule the installation of the correction if your unit is affected as the correction kit becomes available. This work will be done at no cost to your facility.

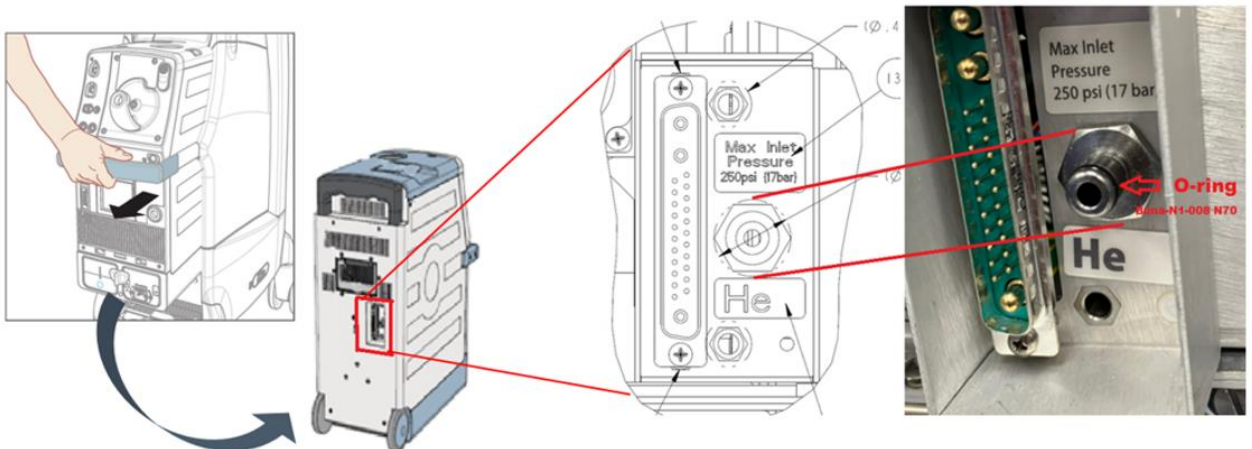
Figure 3: Drawings as pictured in *Cardiosave Hybrid and/or Rescue Operating Instructions*, along with a final picture of the O-ring as it appears on the unit.

Issue 4: Helium Leak at the Pump Console Quick Disconnect Fitting

There have been reports of damaged, worn, or torn O-rings on the Cardiosave Pump Console quick disconnect fitting resulting in helium tank leaks. The quick disconnect fitting is the point of connection that permits the refilling of the Pump Console' s internal helium reservoir when the Pump Console is docked in the Hospital Cart. Please refer to images below for reference.

Datascope/Getinge has received 51 reported complaints of helium leak as a result of damaged, worn, or torn O-rings over a 2 year period.

If user observes any visual damage to the O-ring installed as part of the quick disconnect fitting, please contact your Datascope/Getinge service representative. If possible, remove the IABP from patient use until appropriate repairs can be made.

Datascope/Getinge is currently updating the annual Preventive Maintenance instruction to include replacement of the quick disconnect fitting O-ring.
